The lost Mars Lander: What we think we know about the Mars Polar Lander

Rob Manning
JPL Chief Engineer
JPL/Caltech/NASA

March 4, 2018
IEEE Aerospace Conference

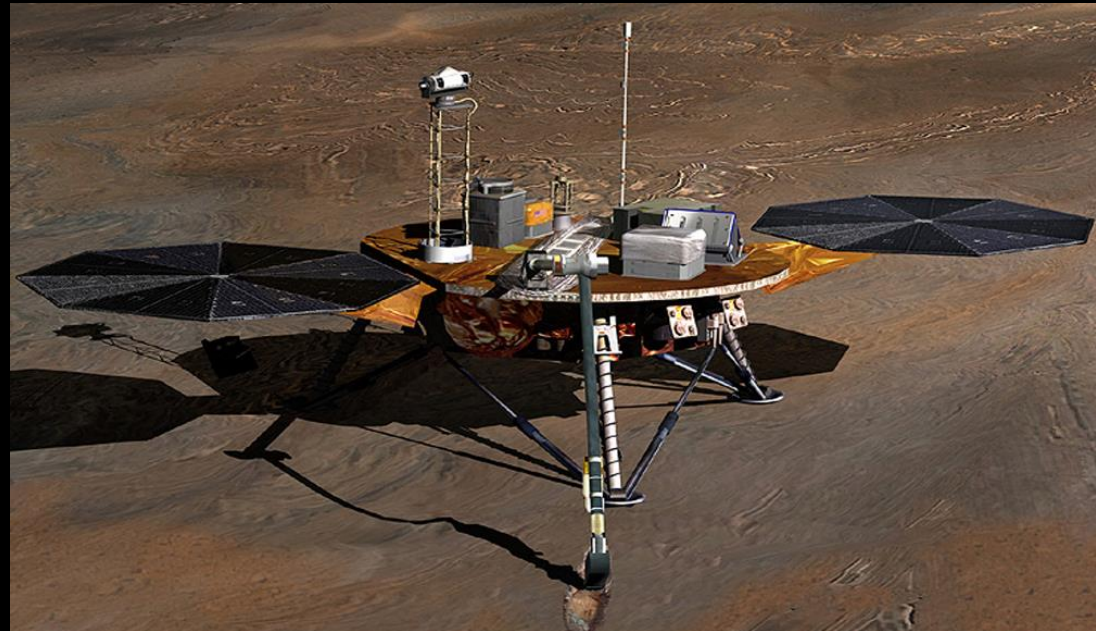
1. Landed in unexpected meter-deep
spidery gullies" in ellipse resulting in
tip-over.

Probability of being MPL Root cause: Low
